DUTCH INDUSTRIAL TARGET GROUP APPROACH: AN ENFORCEMENT STUDY ON THE VOLUNTARY ENVIRONMENTAL AGREEMENT WITH PETROL STATIONS

STAATS, HENRY P.

Regional Inspectorate for the Environment in the Province of South Holland, P.O. Box 5312, 2280 HH Rijswijk, The Netherlands

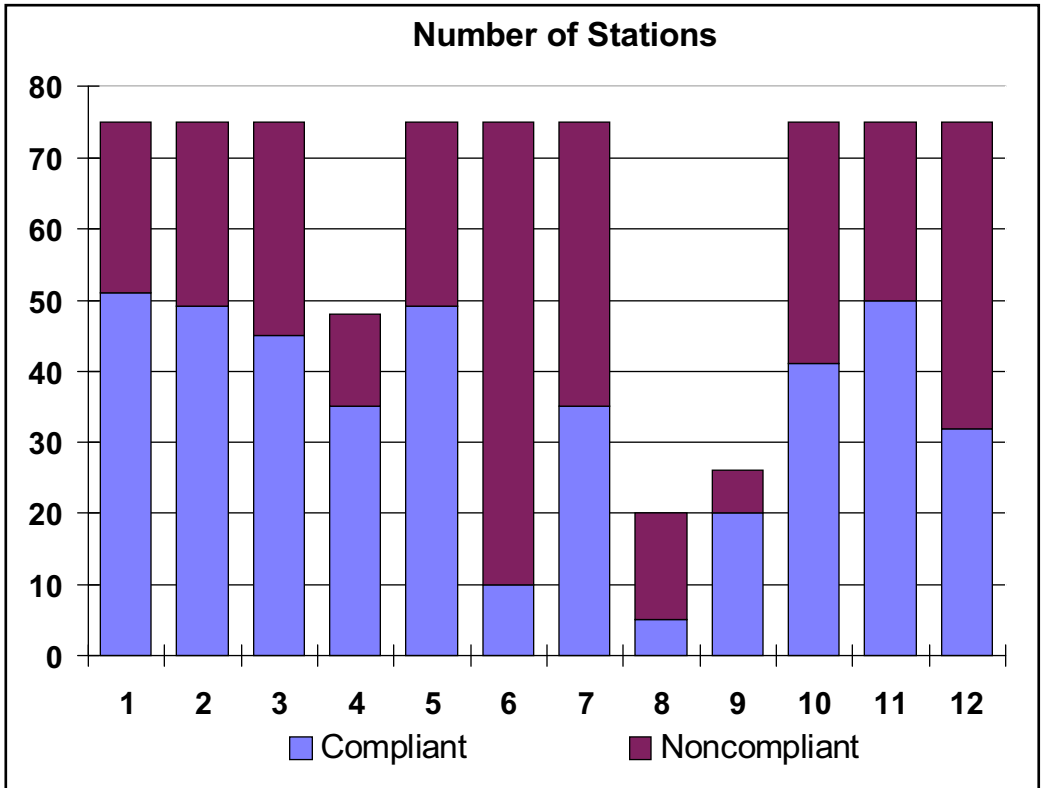
Figure 1. Number of petrol stations scoring positively or negatively against each measure

41% of the measures had not been taken at all the stations together (76 companies). Figure 1 shows that in most cases the installation log is absent. Only 12% of the petrol stations had an installation log. Where it was present, however, it was often not complete.

It also emerges that many mobile delivery units fail to comply with the requirements: where present, only a quarter of cases satisfied the requirements. The picture with static delivery units is also poor. Fewer than half the units had anticollision devices and satisfied the regulations.

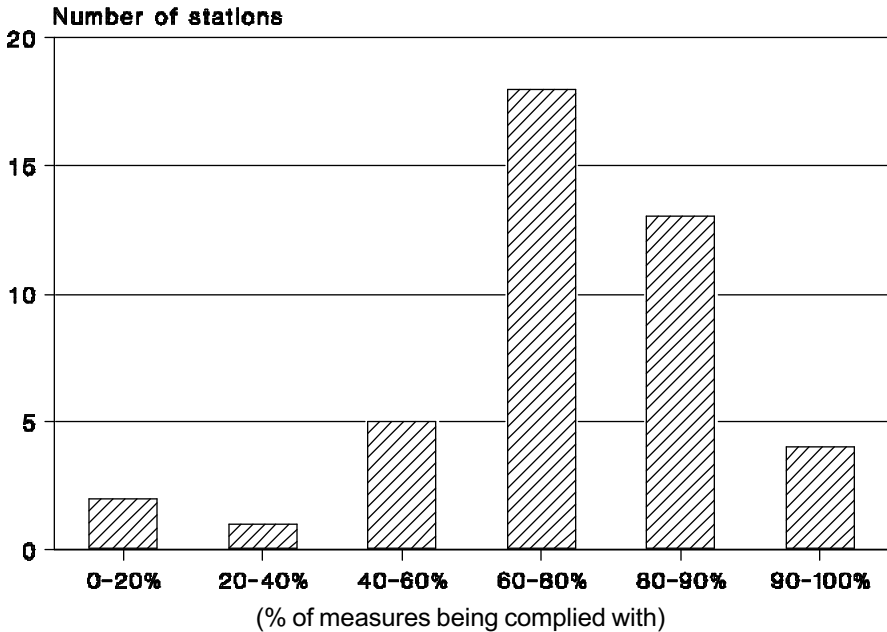
Figure 2. Compliance with measures for petrol stations where the soil is not contaminated or where clean-up is complete

Assessment of the redesign at companies that have completed their soil clean-up operations and at companies where no soil clean-up is necessary revealed compliance with an average 79% of measures. Figure 2 shows the percentage of measures being complied with at cleaned-up companies and those not contaminated.

Progress in implementing the fourth phase (redesign) was modest. On average, 79% of the provisions were in place at companies where there was no further clean-up in operation (43 stations). This means that in a number of cases no preventive measures to avoid soil contamination had been taken.
