Mandara Estates

hazardous waste dumping
a case study

Roger Dixon
Senior Superintendent
Forensic Science Laboratory

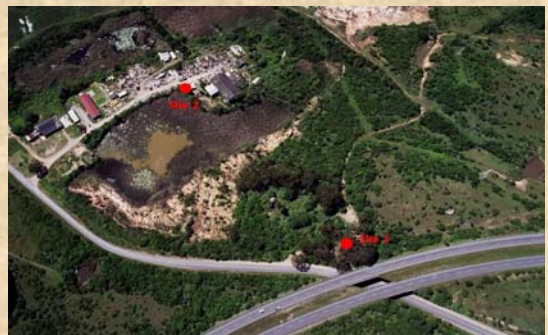
Aerial view of the site next to bridge where it was noted that a waste material dump (Site 3) had been removed, when visited on 2003-12-12.

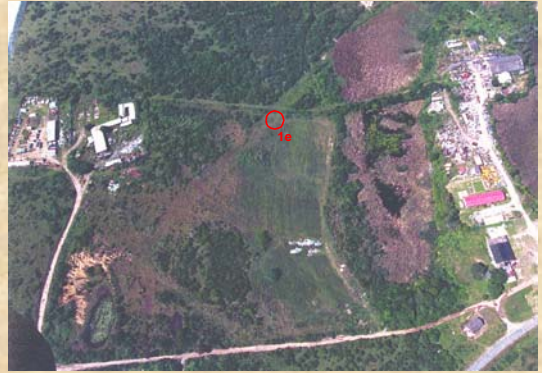
Due to the large quantities of scrap metal lying around on the surface on the hill and often hidden by the long grass, EM detection was severely compromised.

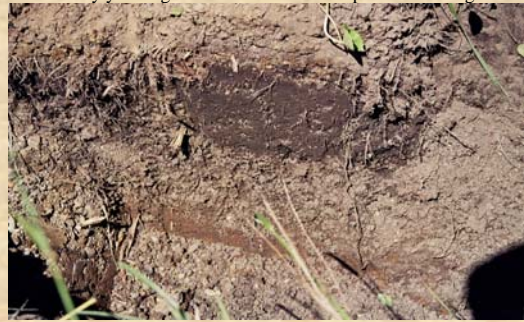
Site 1a¹ - Excavation site on hill next to building complex with pools of liquid and drums of presumed waste.

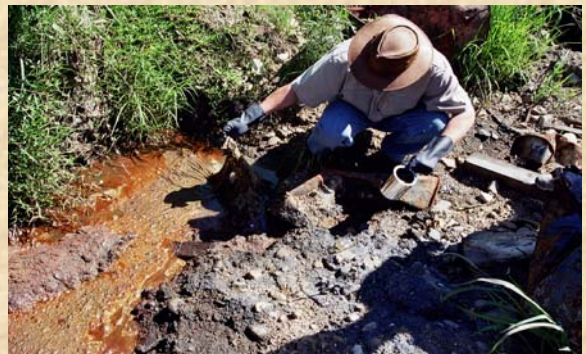
Previous investigations on the site by other agencies caused further pollution and was uncontrolled, giving rise to potential problems.

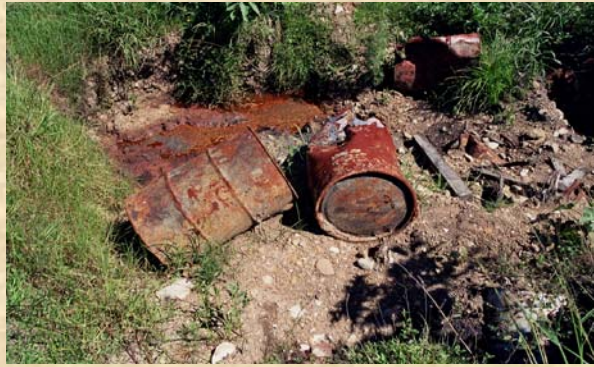
Site 1a² - Excavation site on hill next to building complex where waste was emptied out to drain into the soil.

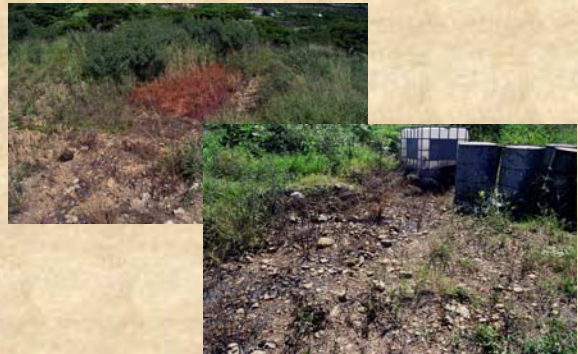
Site 1a² showing where paint wastes have been poured out into a drainage pond. A polymer film has developed on the surface of the pond.

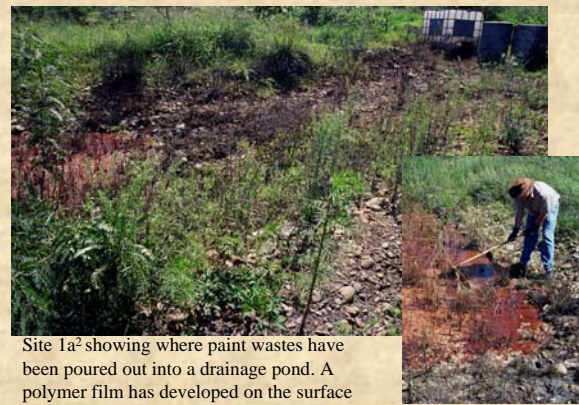
Site 1a² - A close up of the polymer film on the drainage pond. Note also that all the vegetation is dead.

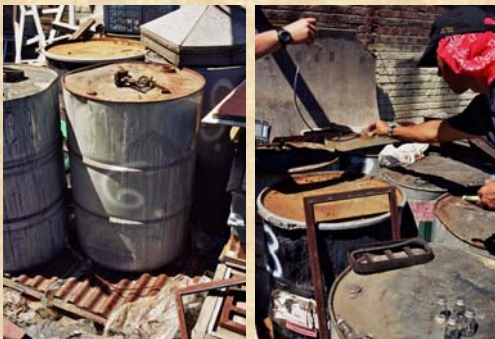
Site 1b - Drums just outside the roofless room of the building complex, in the courtyard.

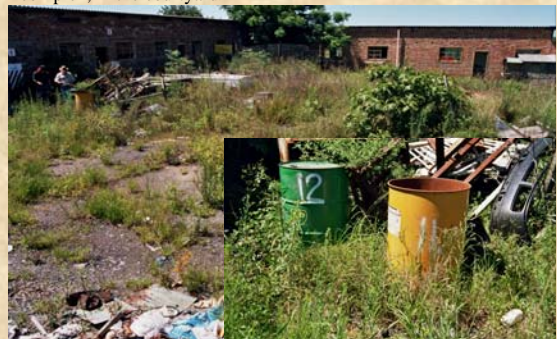
Site 1c - Excavation in courtyard of building complex next to a waste heap. In the excavation are mainly empty flattened drums.

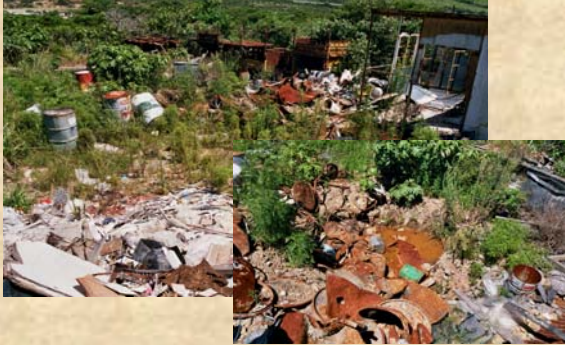
The waste heap in the courtyard at Site 1. It is 25 m long, 5 m wide (average) and approximately 1.5 m high in the middle.

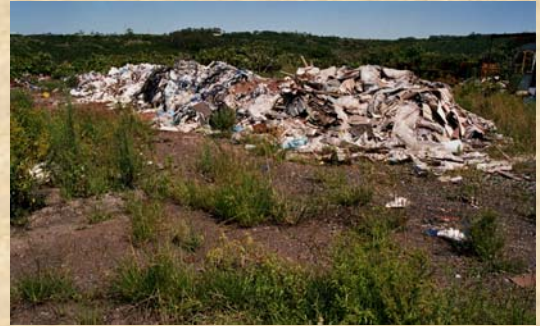
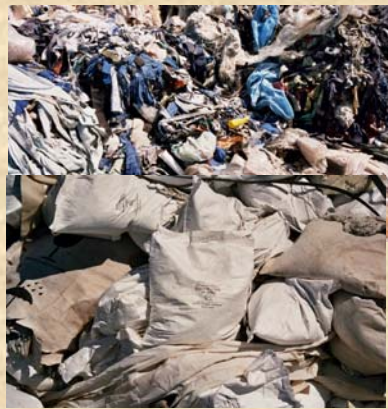
The waste heap consists predominantly of what appears to be factory waste (cloth, etc.), plastic straps and waste, leather waste, carpeting offcuts and drying agent (bags of dessicant).

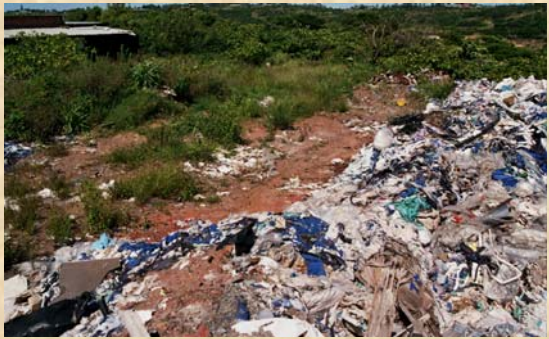
Site 1f - In the clear patch is blue paint sludge and ash on top of old brick paving, next to the waste heap.

Here and in other areas nearby it appeared as if the layer of paint sludge accumulated due to paint wastes having been poured onto the surface and the sludge was left after drainage and evaporation.

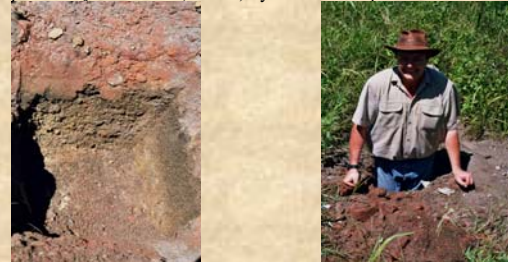
A test pit was dug in the courtyard to determine if the soil had been disturbed. This revealed that the area had been paved with bricks placed on top of soil which appeared to be undisturbed in recent time. From this test pit and other observations, it appears as if the entire courtyard had been paved with bricks, and the only site at which material had been buried was that which had been previously excavated (Site 1c) by DEAT in September 2003.

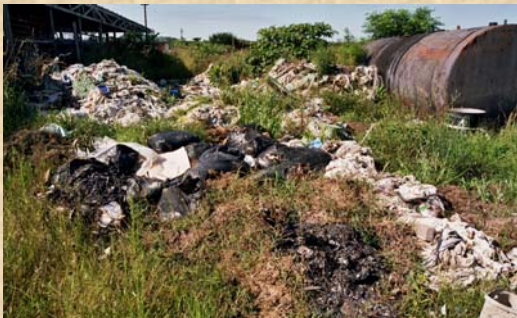
Site 1g - Behind building complex next to the LTA Grinaker yard. There were piles of burnt material, mainly cotton waste and rubbish, and lots of drums.

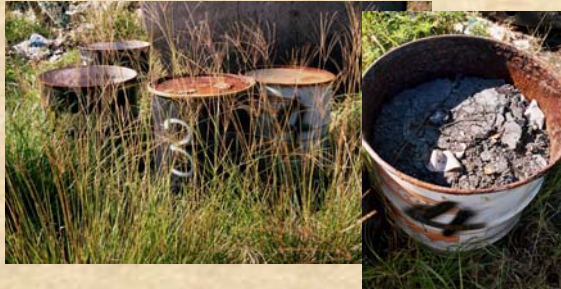
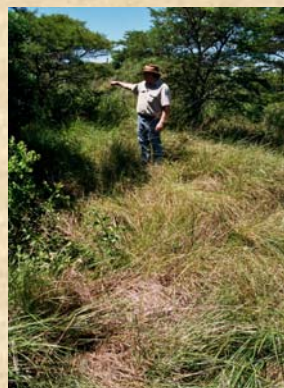
Drums 1 to 4 were full of what appeared to be paint sludge, mixed with plastic and soil. It was evident that this material was the result of paint waste which had been poured out onto the soil, and once the volatile and fluid component had drained or evaporated away, the sludge residues were dug up and placed in drums.

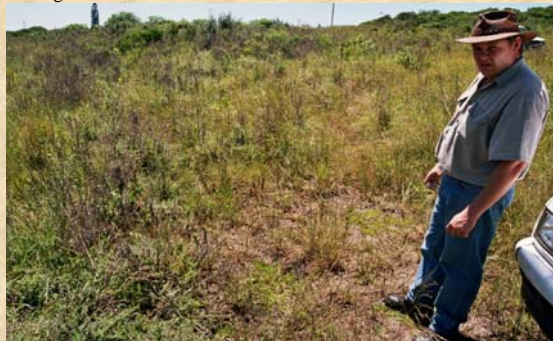
Drainage from the burial site is directly downhill in the direction of the reed beds at Site 2. Vegetation below the drum burial (Site 1a¹) and the drainage pit (Site 1a²), about 20 metres downhill, is dead in places from groundwater pollution (Site 1d).

Site 1e - Further down the hill slope is a seep in the power line cutting.

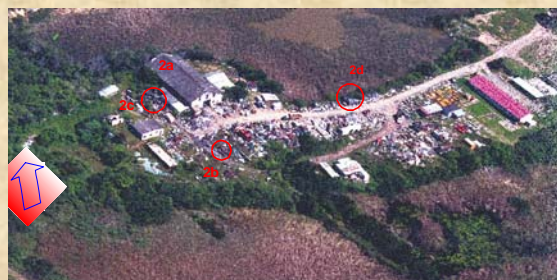
Aerial photograph showing Site 2. The light area to the extreme left (arrowed) is a waste dump which does not appear in photographs taken by DEAT in September 2003.

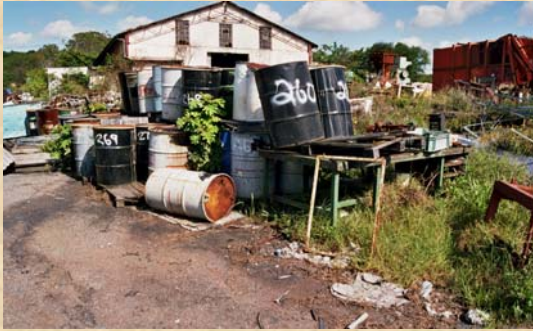
Site 2b - Drums in front of the plastic recycling works. 4 drums were sampled.

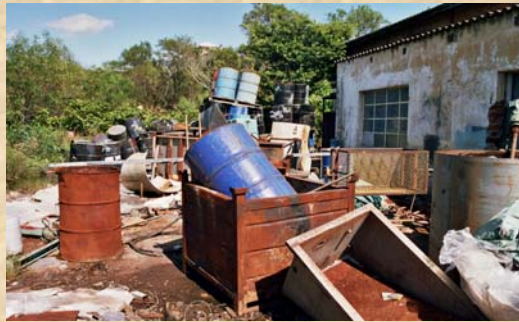
Site 2c - Drums at the rear of the plastic recycling works. 4 drums were sampled.

Site 2c showing how the stacked drums have fallen over and some have leaked into the surrounding soil.

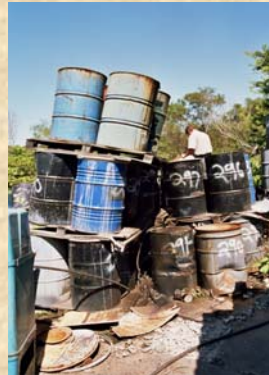
Site 2c. Additional views showing the collapsing stacks of drums containing paint wastes

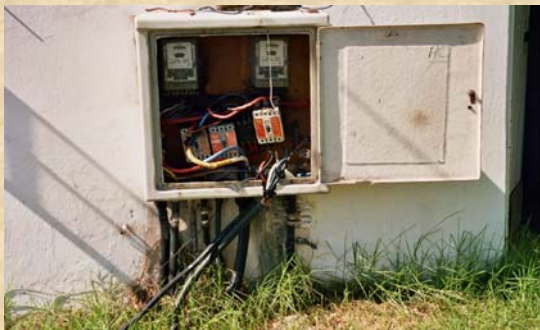
Between Site 2b and Site 2c was this electrical installation. The condition of the wiring poses a potential fire hazard with all the plastic waste and paint wastes in the near vicinity.

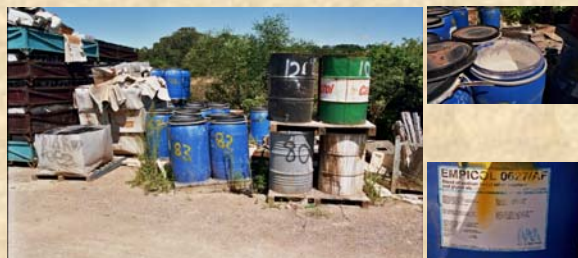
At Site 2d there were 26 blue plastic drums which contained a white scented powder. These drums were labelled as being EMPICOL and containing either ammonium lauryl sulphate or a blend of sodium lauryl ether sulphate and glycol stearate. However, a sample from the drum marked "82" was identified as talcum powder.

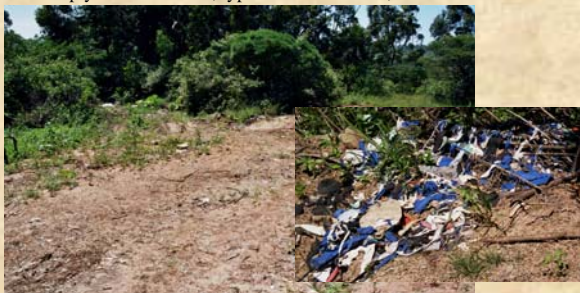
At Site 3, next to the bridge, evidence of recent activity was found when visited on 2003-12-12, in the form of very fresh earthmoving equipment tracks. The remains of a large dump of waste, mainly the same type of material as found at Site 1 and Site 2, as well as a variety of empty alcohol bottles, typical of a bar waste, was visible.
