Mandara Estates

hazardous waste dumping
a case study

Roger Dixon
Senior Superintendent
Forensic Science Laboratory

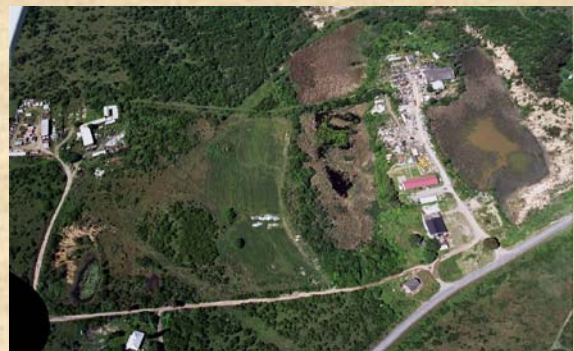
Aerial view of Mandara Estates. Site 1 is on the hill to the left and Site 2 is the complex on the right.

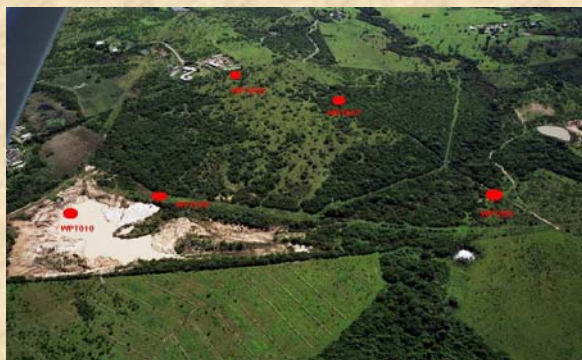
Aerial view of the site next to bridge where it was noted that a waste material dump (Site 3) had been removed, when visited on 2003-12-12.

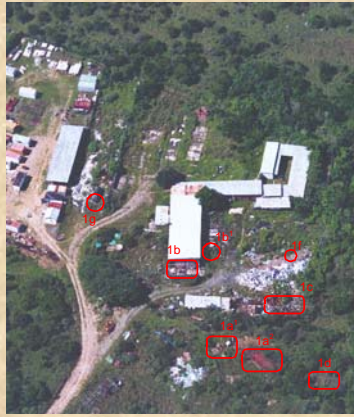
Aerial view showing Site 1 at left and Site 2 at right.

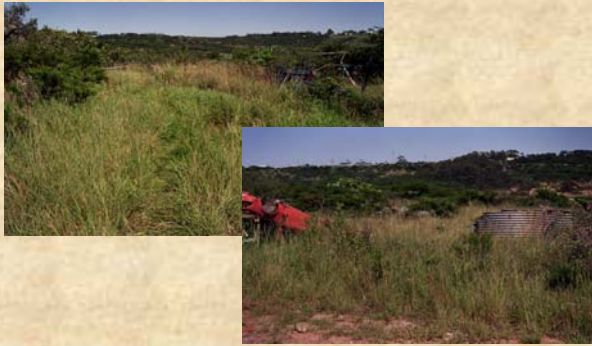
The site has been in use for many years and there are old water pipes and other metal objects long buried. The soil appeared fairly undisturbed but contained pieces of brick, possibly old rubble buried many years ago and not related to the present investigation.

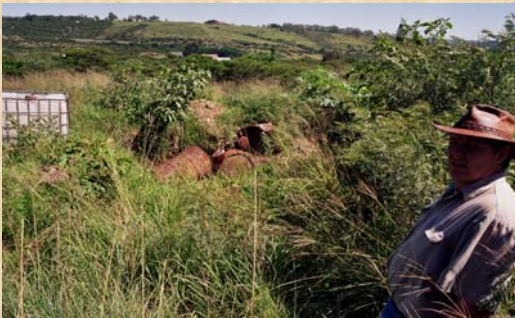
Supt. Vermeulen sampling at Site 1a¹

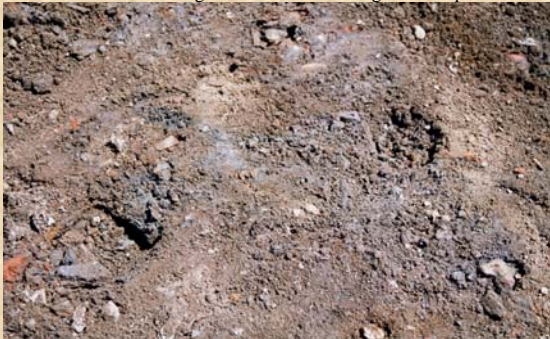
A test pit was dug in the courtyard to determine if the soil had been disturbed. This revealed that the area had been paved with bricks placed on top of soil which appeared to be undisturbed in recent time. From this test pit and other observations, it appears as if the entire courtyard had been paved with bricks, and the only site at which material had been buried was that which had been previously excavated (Site 1c) by DEAT in September 2003.
